MISCELLANEOUS PAPER SL-86-9

ALKALI-SILICA REACTION IN CONCRETE FROM FONTANA DAM, NORTH CAROLINA, TENNESSEE VALLEY AUTHORITY

Alan D. Buck, Katharine Mather

Final Report

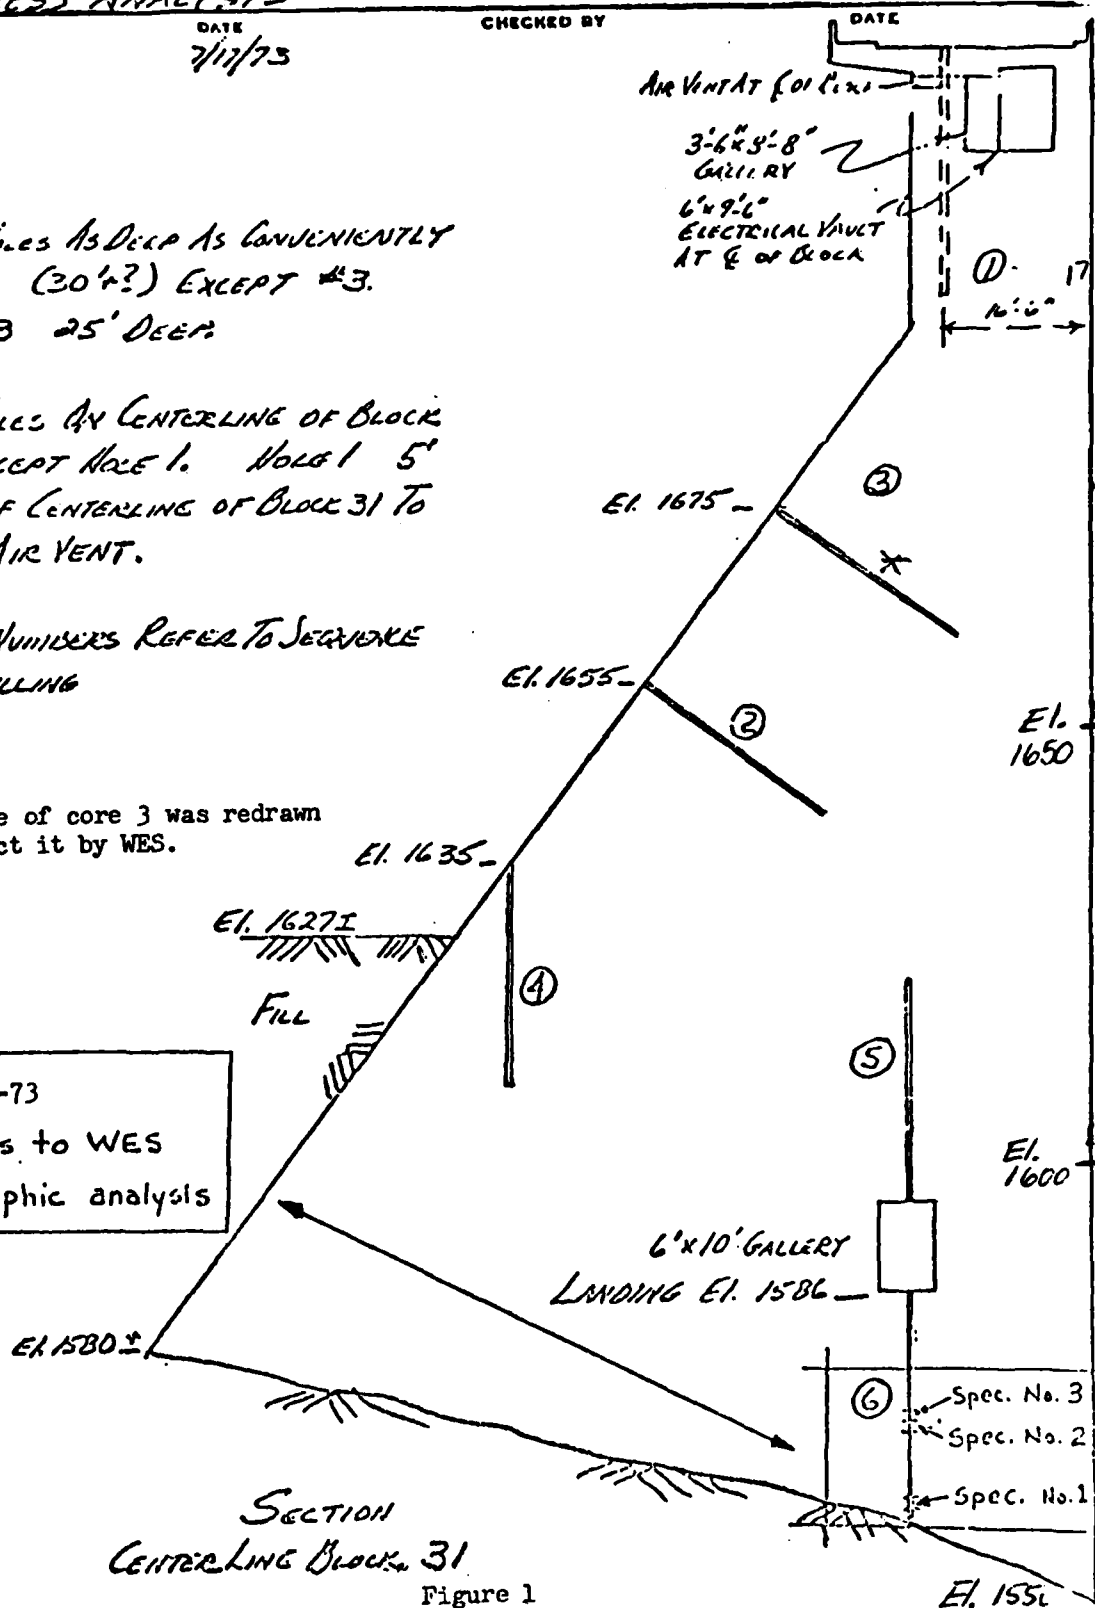
10. Figure 1 is a copy of the TVA sketch which shows core locations in block 31. Figures 2 and 3 are the TVA and WES logs of hole 1 (CON-3-6, 8, 9); figures 4 and 5 are the TVA and WES logs of hole 3 (CON-1, 2, 7); figure 6 is the WES log of hole 6 (CON-10-12). One break in the core from hole 3 appears to antedate drilling. The break at elevation 1567.8 (hole 6) appears to be old; the break at the bottom of specimen 2 from hole 6 (elevation 1557.7 may antedate drilling; the break at the bottom of specimen 3 appears to be fresh.

12-10-73
Sent 3 cores to WES
for petrographic analysis

20. Figure 1 shows that core hole 1 is at the highest elevation and nearest the upstream face. Core hole 6 is at the lowest elevation and not much farther from the upstream face than core hole 1. Core hole 3 starts at elevation 1675 and dips into the dam normal to downstream surface. TVA Technical Monograph No. 69 shows on figure 27 that normal reservoir levels range from 1590 ft in late December to 1708 ft in May through August. On this basis hole 6 is usually below reservoir level; the same is true of hole 3 on the downstream face; hole 1 starting from the roadway has half or more of its length above normal maximum reservoir level.

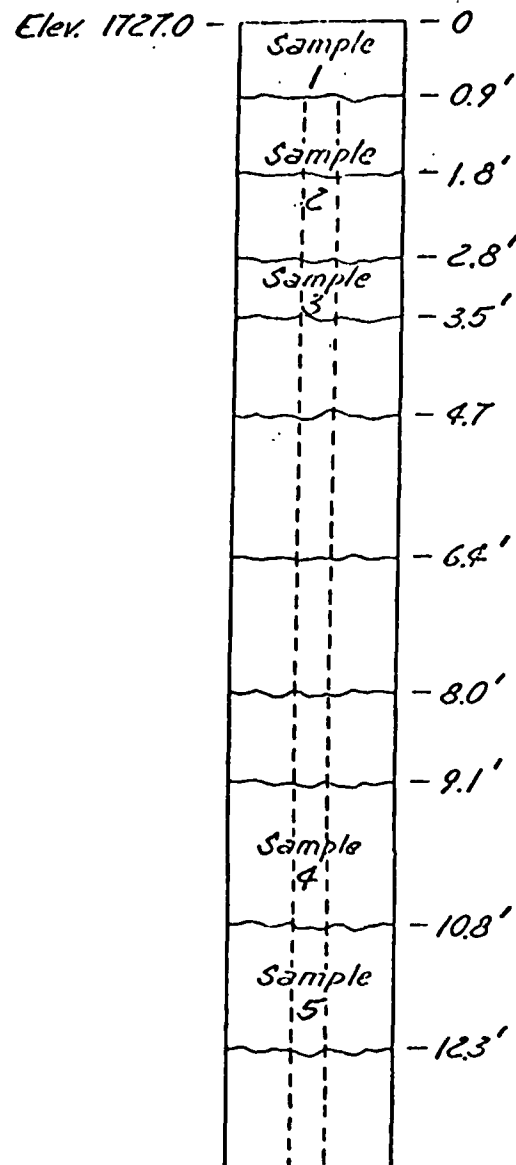
Figure 2

HOLE 1

FONTANA DAM			
BLOCK 31 &			
6 INCH OVERCORE SAMPLES			
TENNESSEE VALLEY AUTHORITY MATERIALS ENGINEERING LABORATORY			
SUBMITTED	RECOMMENDED	APPROVED	
R. J. J.			
PORTVILLE		1

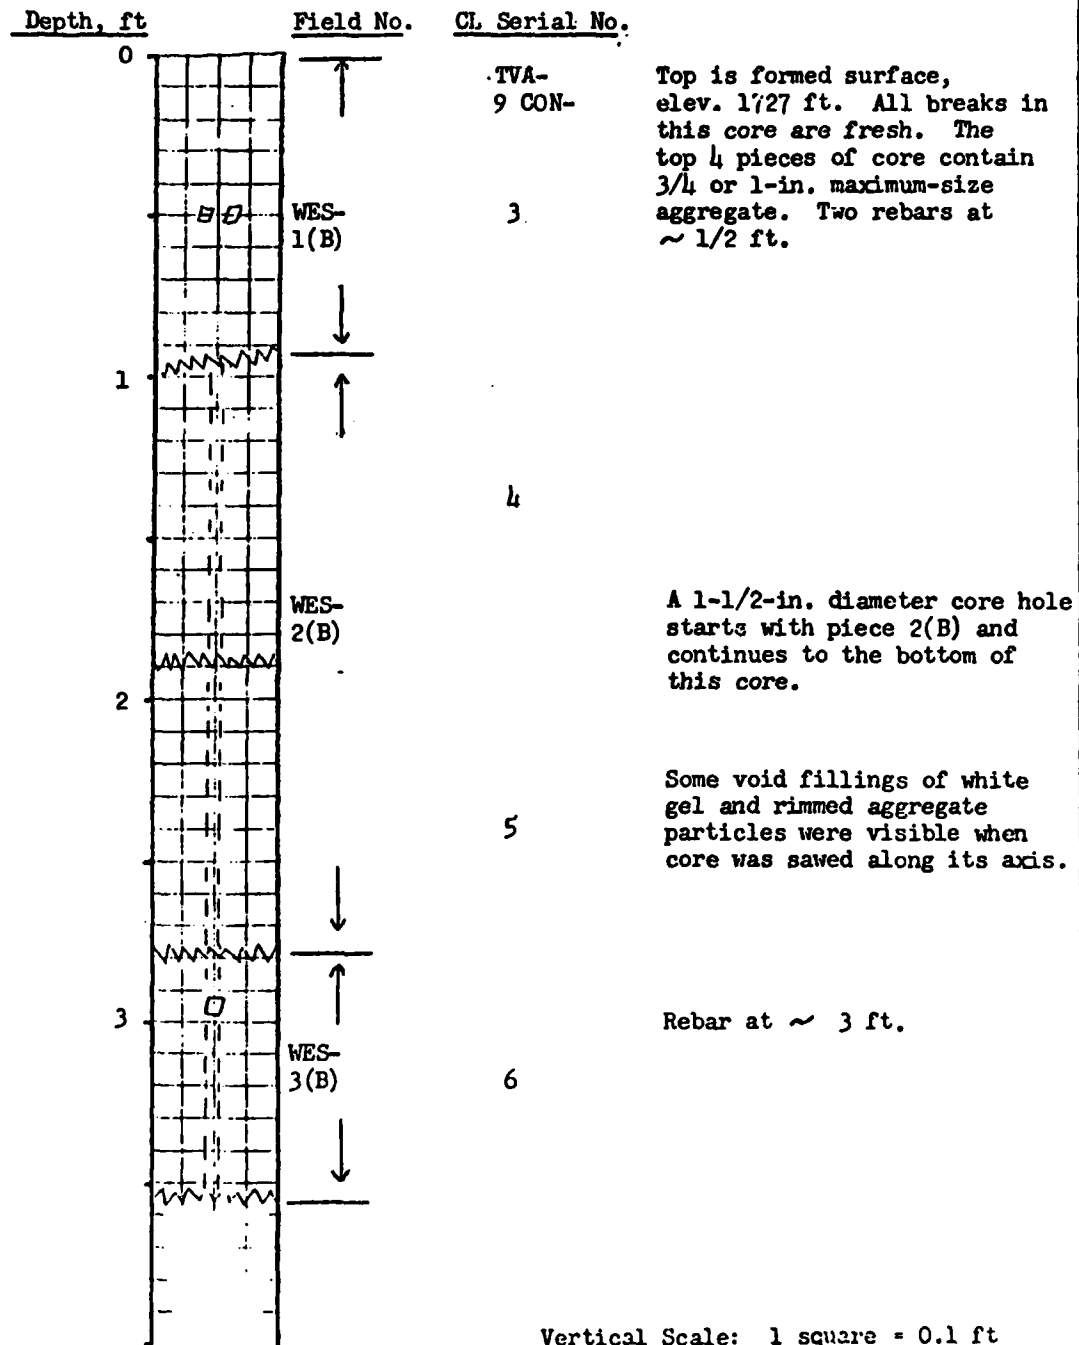
Figure 3

LOG OF 6-IN. DIAMETER TVA CONCRETE CORE NO. 1
FROM BLOCK 31, FONTANA DAM

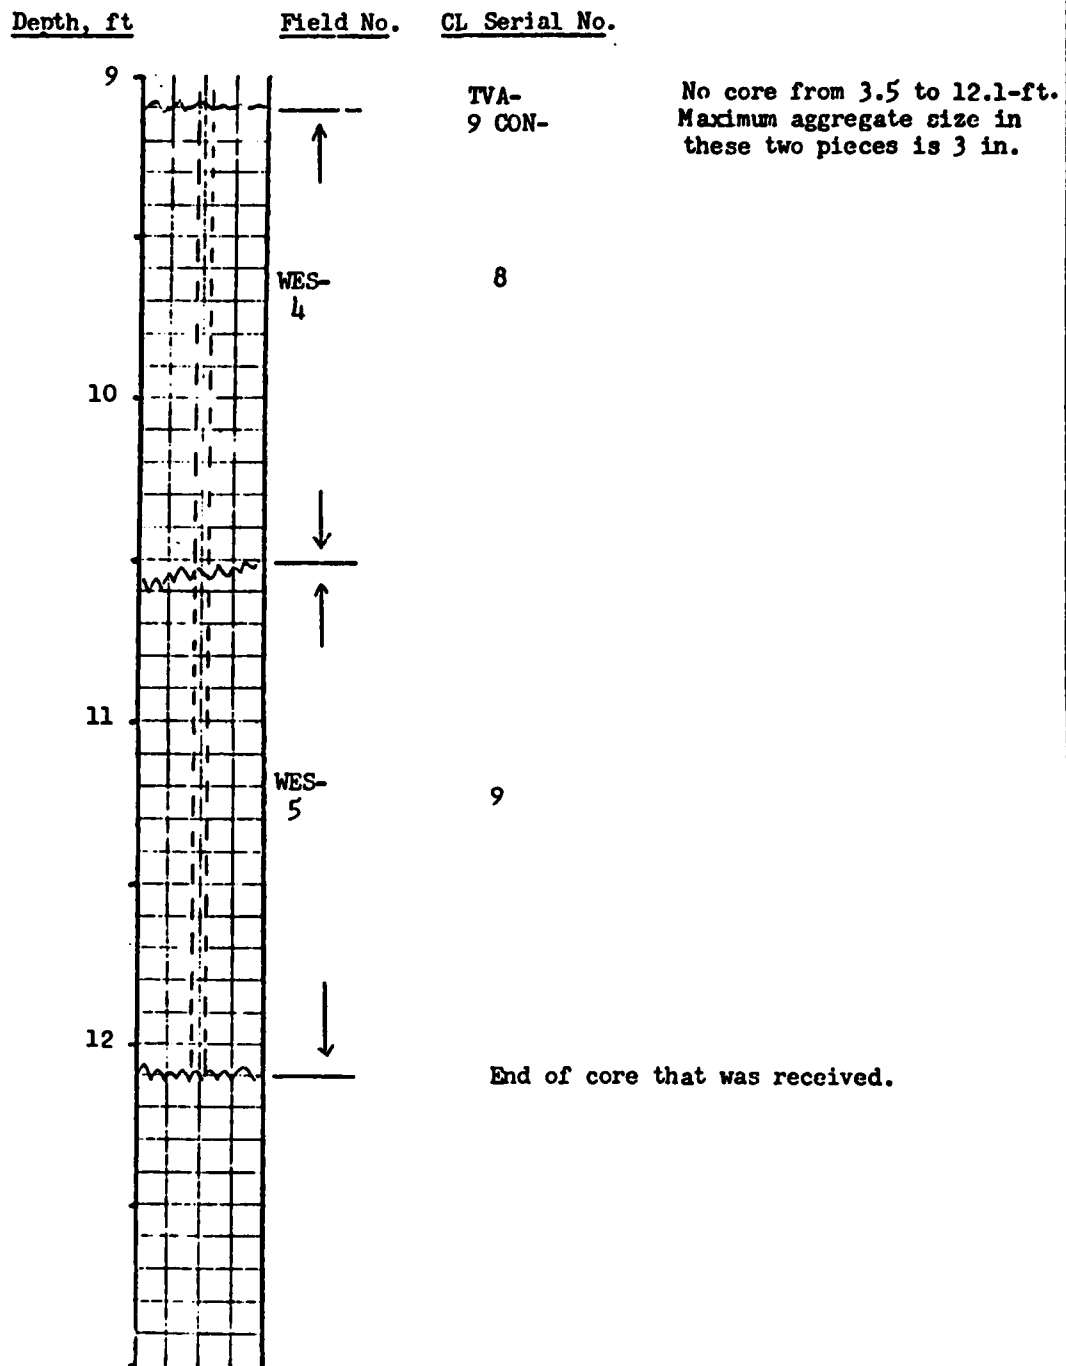
Figure 3 (continued)

TVA CORE 1 (CONTINUED)

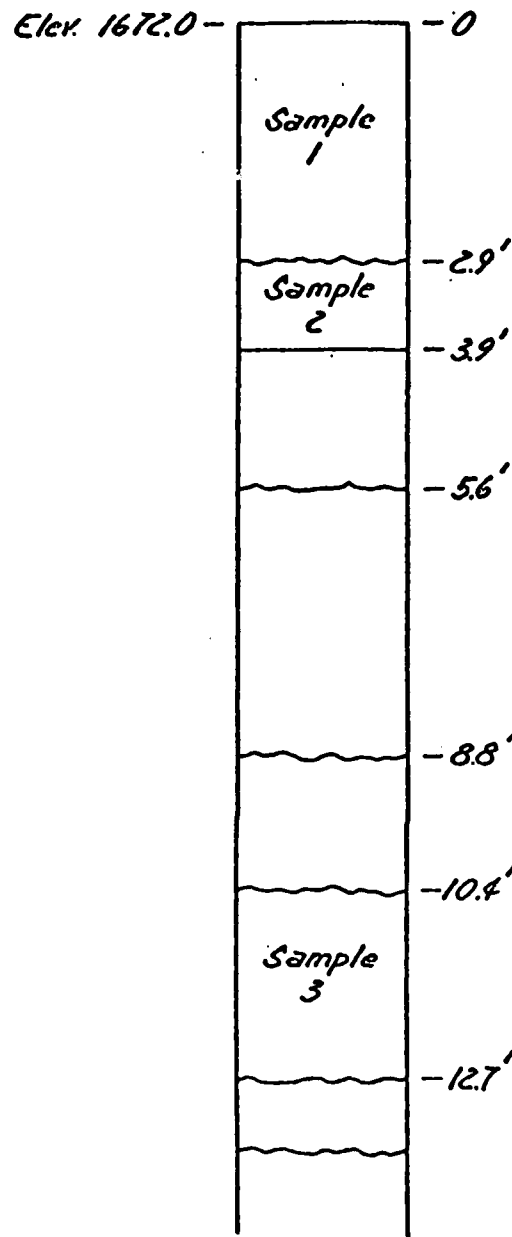
Figure 4

Hole 3

FONTANA DAM			
BLOCK 31			
6 INCH SOLID CONCRETE CORE			
TENNESSEE VALLEY AUTHORITY MATERIALS ENGINEERING LABORATORY			
SUBMITTED	RECORDED	APPROVED	
PLP			
ENDELL

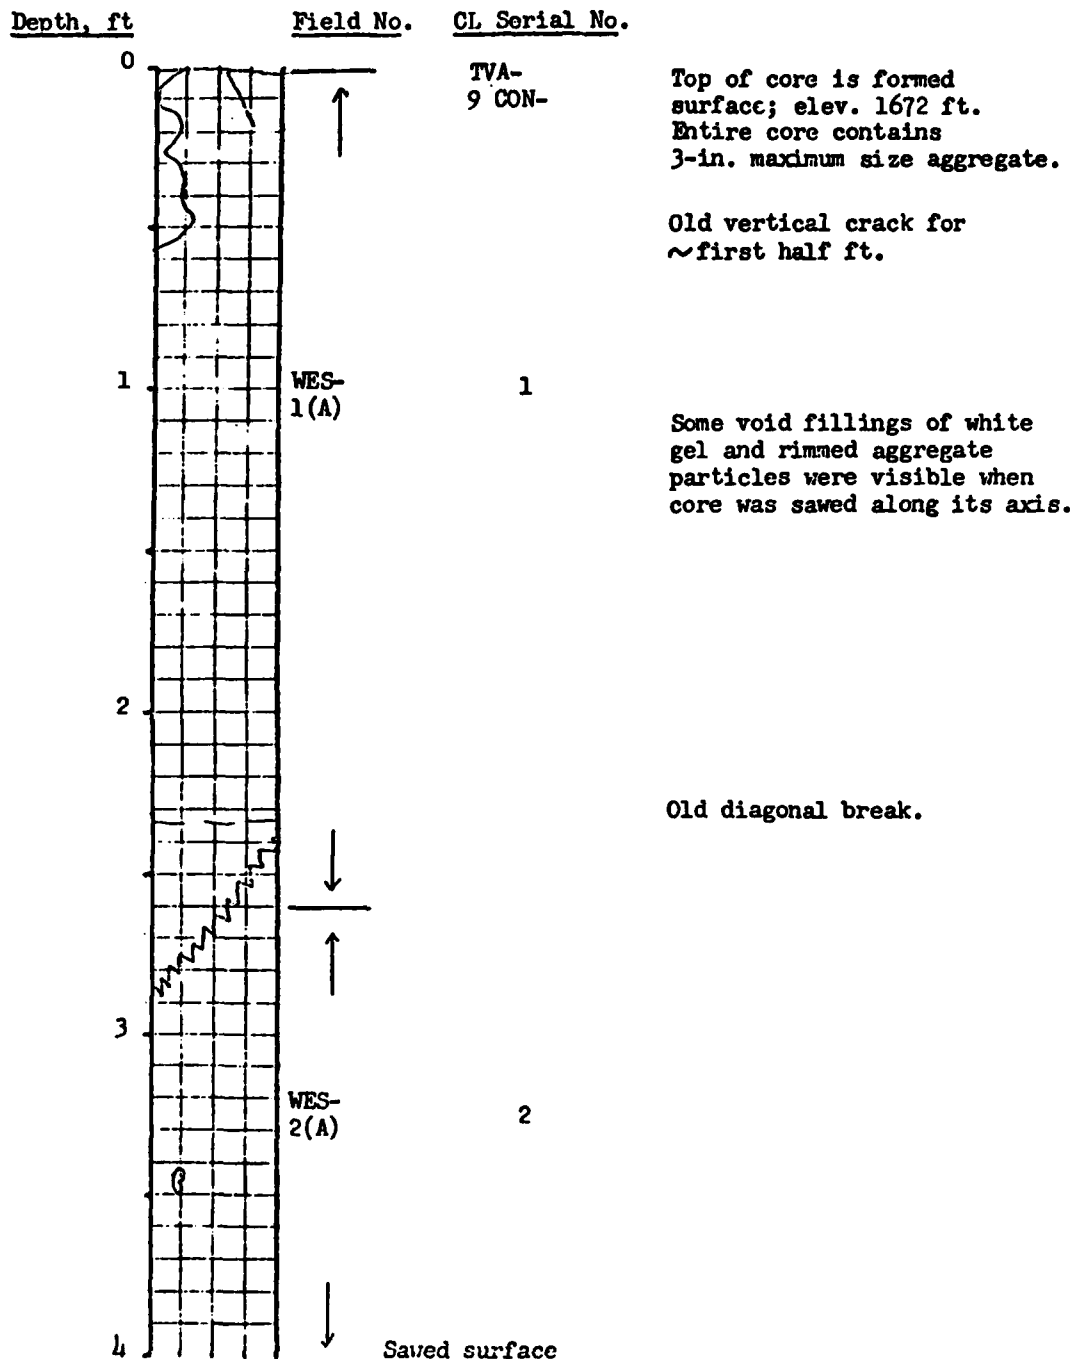
Figure 5

LOG OF 6-IN. DIAMETER TVA CONCRETE CORE NO. 3
FROM BLOCK 31, FONTANA DAM

Vertical Scale: 1 square = 0.1 ft

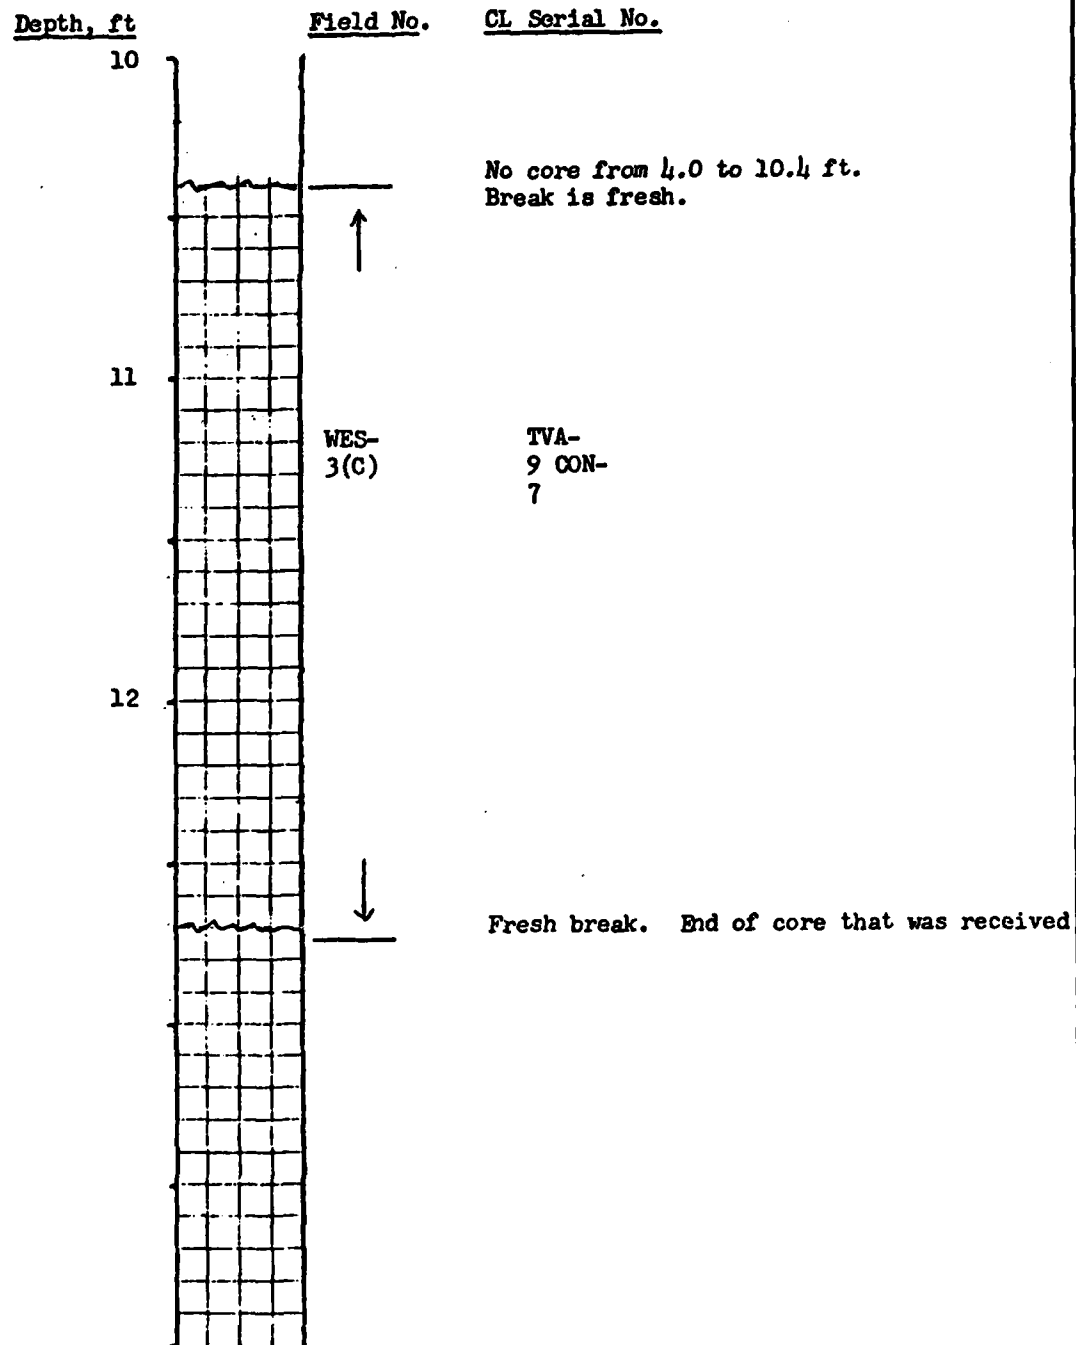
Figure 5 (Continued)

TVA CORE 3 (CONTINUED)

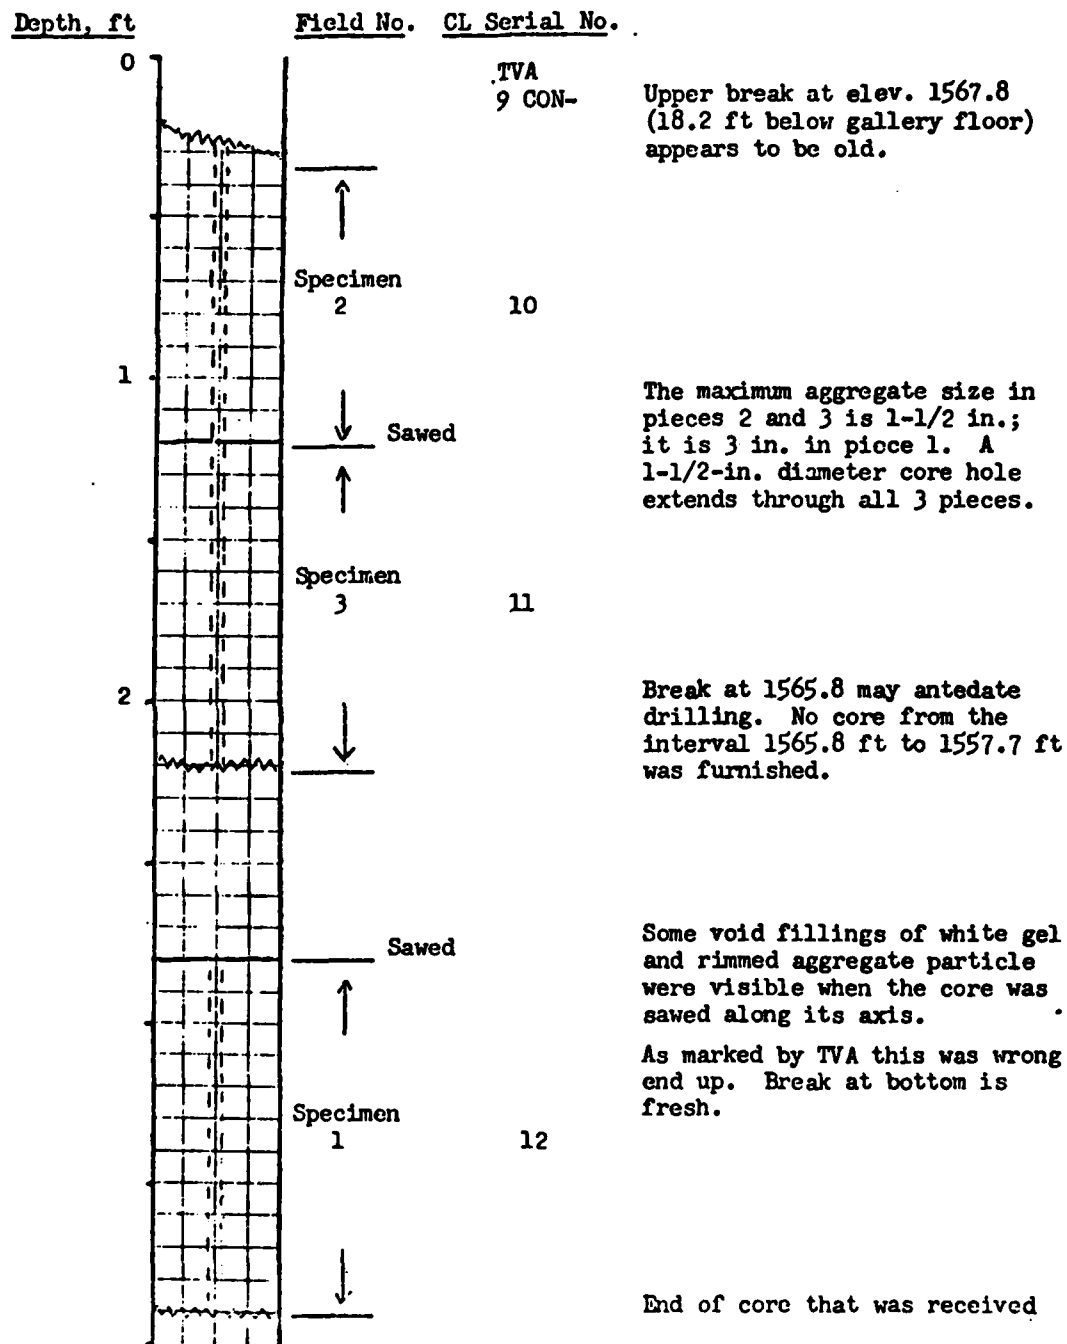
Figure 6

LOG OF 6-IN. DIAMETER TVA CONCRETE CORE NO. 6,
BLOCK 31, FONTANA DAM

Vertical Scale: 1 square = 0.1 ft
